Safeguard Home Inspections Ltd.

Inspection Report

**Inspector: Sam Lorefice,
Safeguard Home Inspections Ltd.
Halifax, NS.**

January 10, 2012

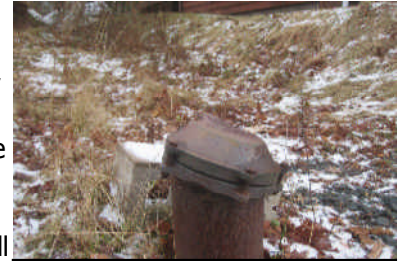
Install cap properly, protect from vehicle

Suggest client install adequate protection at the well casing at the driveway area to prevent damage from vehicle impact.

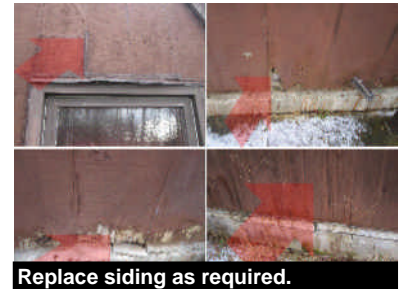
Damaged/cracked/cupped siding noted due to lack of regular maintenance. Client should insure the wood siding is painted/stained every 5 to 7 years to prevent further damage. It is important that these surfaces are kept well protected to ensure a maximum service life. Subsequent paint/treatment maintenance can also be carried out as the usual signs of failure such as cracking, chipping or blistering of the exterior skin/surface become evident. The cracks and separations have been filled with caulking/sealants.

Contact between the exterior wall surface and grade was noted at the north side of the residence. This state forms a condition that is conducive to infestation to wood deteriorating organisms. It is important that material such as leaves,

Replace siding as required.

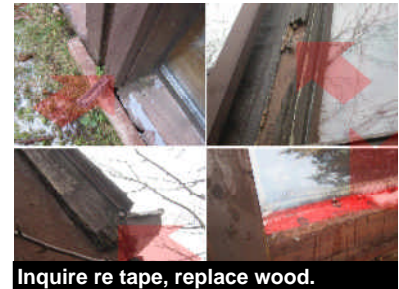
Deteriorated/rotten wood trim noted at the window and door trim and the fascia boards. Suggest client replace as required to prevent further damage.

Red Tuck tape was installed at the base of the northeast window. This indicates there have been problems at these locations. Suggest client consult with the present owner regarding the reason for the installation of the tape.

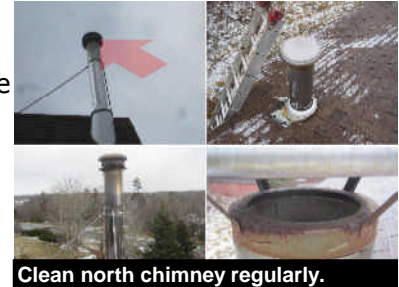
Creosote noted inside the firebox/liner, Creosote (Soot) is the product of incomplete wood combustion. Creosote is formed by small carbon particles carried by the exhaust gas stream into the chimney. Creosote is formed by tar droplets which condense on cool surfaces in the appliance/venting system. Creosote may be in a hard or sticky/shiny form which looks like black paint, or it may form a dry flaky deposit. Creosote is **EXTREMELY** combustible. The ignition of creosote in chimneys can cause damage to the chimney and if the chimney fails, may cause ignition of combustible materials adjacent to the chimney surface. Creosote must be removed regularly from the venting system to reduce the risk of chimney fires.

Suggest client have the chimney cleaned by a qualified/certified chimney sweep, prior to use, subsequent cleanings should take place after each chord of wood is burned and before the start of each heating season.

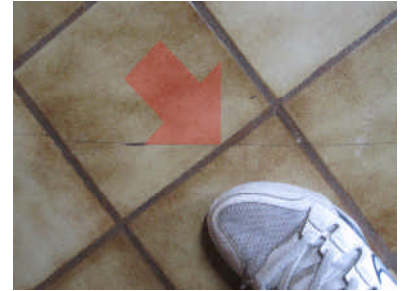
The slab is not level/even, consequently tiles have cracked and the grout is deteriorating.

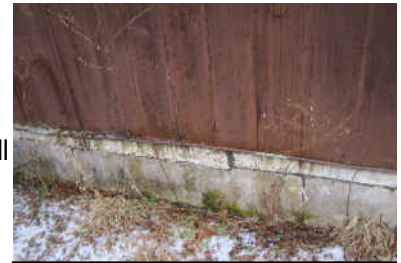
The concrete foundation walls were not visible at the exterior due to the insulation covering the walls. The client should insure the insulation is adequately protected/covered with plywood/concrete skim coat. The insulation will deteriorate if it is exposed to the harmful UV rays of the sun.

Concrete not visible, cover insulation.

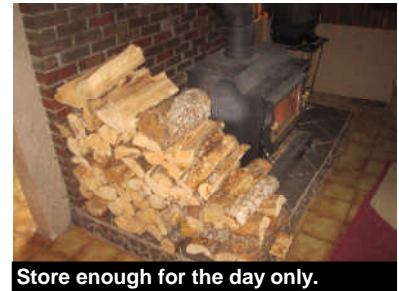
The inspector was concerned regarding the wood stored inside the home. This condition is a health hazard relative to excessive moisture levels in the home and animal/rodent infestation can occur. Suggest client remove the wood out of the living area to prevent further damage.

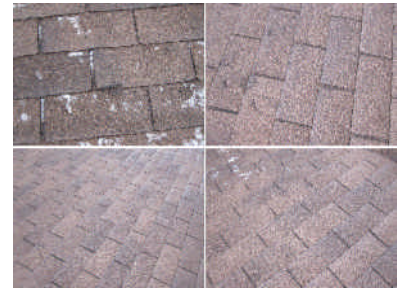
The front section of the roof appears serviceable/within useful life with signs of normal wear and aging. Cracking and clawing of the rear section of the shingles are the result of long term weathering and an advanced shingle age. Felts are showing through. Anticipate the need to replace the rear roof covering in the not too distant future.

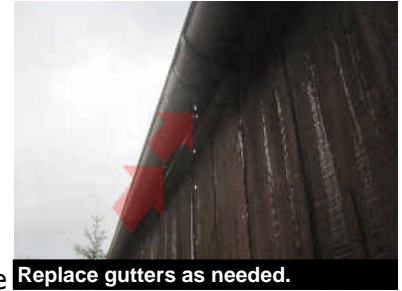
The rear gutters were leaking at the time of the inspection. Suggest client contact a qualified gutter/eavestrough contractor and make repairs/replacements as required.

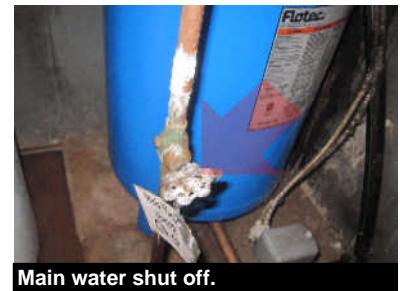
Main water shut off.

Water main shut off (metal gate valve) is located at the pressure tank. Valve not tested, Main line is 1/2 inch diameter, Water pressure appears adequate.

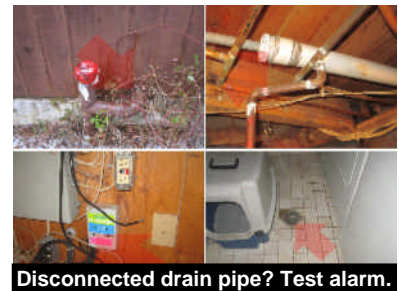
Appears serviceable, Plumbing vents appear serviceable.
The inspector was curious as to why the drain pipe servicing the drain in the laundry room was removed. Suggest client consult with the present owner.

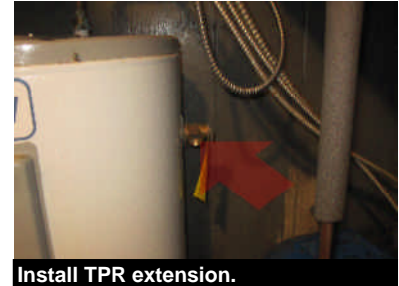
Water is heated through an electric water heater. Hot water was readily available at the time of the inspection. The date on the water heater was 2007. Water heaters have a life expectancy of 8 - 12 years. Water heater life expectancy is based on the number of occupants in the building and overall usage. The unit has a cold water shut off valve. This unit is of good quality and appears to be

Pressure relief valve, located at the top of the water heater, is installed without a drain line. This copper drain line should flow by gravity to 6 inches from the floor and its use is required by the plumbing code. Lack of the drain line constitutes a safety hazard, as a massive blow off of scalding steam could unexpectedly occur should this safety valve ever be called into use. This problem typically occurs where a water heater has been replaced/installed by someone other than a licensed plumber. A drain line extending to the floor of the house should be installed for your safety.

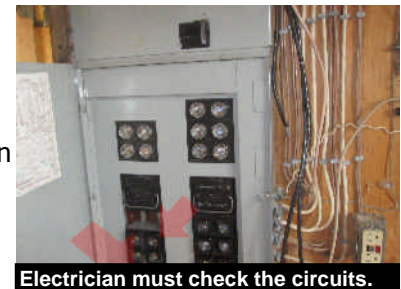
Circuit and wire sizing correct so far as visible, Grounding system is present. Unused openings in the panel are missing covers. BRANCH CIRCUIT PANEL- UNUSED OPENINGS: Unused openings at the front of an electrical panel present a safety hazard to probing fingers. Small plastic covers made for covering such openings are available at most hardware stores for under \$1.

Faulty circuits were noted at the bottom left and the 3rd on the left from the bottom, when the inspector obtained a thermal image with his infrared camera. Suggest client contact a qualified electrician for further review and make repairs/replacements as required.

Electrician must check the circuits.

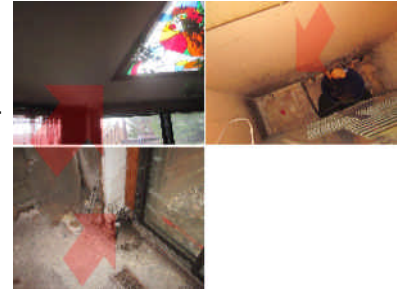
Moisture stains/damage viewed at the north side entrance, above the southeast sliding door and behind the stove. Client should expect wall assembly damage at these areas. Suggest client remove the damaged sections and make repairs/replacements as required.

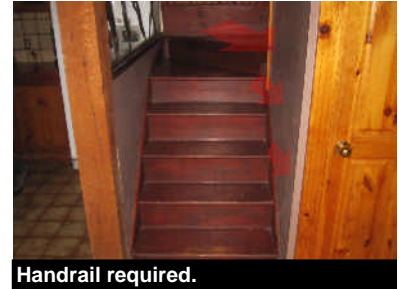
Interior stairs serviceable.
Handrails Missing! at the stairs leading to the top floor, this is a safety concern. Suggest client contact a qualified carpenter and install a handrail as required to prevent falling and personal injury.

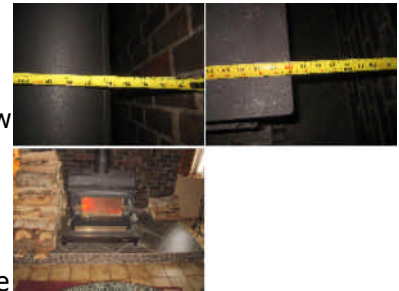
Free-standing certified air tight woodstove.
Hearth extension is adequate. The unit was in operation at the time of the inspection consequently the inspector was not able to view the interior of the system.

Improper clearance to combustibles noted at the rear of the unit and the flue vent. Suggest client contact a qualified WETT certified woodstove installer for further review and make repairs as required, to insure the safe and effective operation of the system. Recommend cleaning before use by a certified chimney sweep.

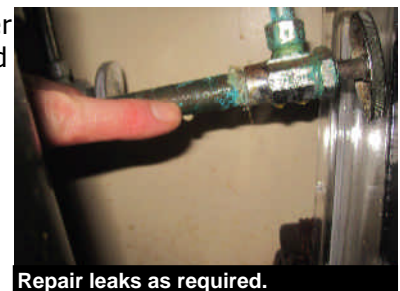
Leaks noted under the sink. A licensed plumber should be called to make further evaluation and repairs as needed.

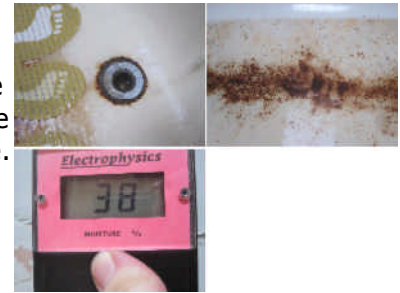
The tub is corroded and will require replacement or refinishing. High humidity readings were noted at the lower section of the tiles in the shower. Client should expect to have to replace the tiled enclosure in the near future. Suggest client remove the tiles and check the wall assembly for damage and make repairs/replacements as required.

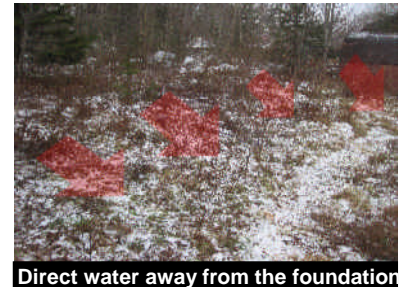
Landscaping and lot topography are examined during a residential house inspection as they can have a significant impact on the building structure. It is important that surface runoff water is adequately diverted away from the building, especially in the areas that have expansive soil characteristics. Low spots or depressions in the topography can result in ponding water that may exert hydrostatic

pressure against the foundation. This pressure can cause a variety of effects on the building. A high water table, or excessive ground saturation can also impact septic systems. Even over watering of gardens and shrubbery can have significant effects. A similar impact can result from tree roots growing against the foundation and causing cracking or movement of the structure. It is a standard recommendation that lot grading slopes away from the building. Grading should fall a minimum of one inch every foot for a distance of six feet around the perimeter of the building. It is also important that tree branches are not permitted to overhang the roof and that all landscaping is kept well pruned and not permitted to grow up against any part of the building. Inspector was concerned regarding the slope of the property at the rear of the building. Suggest client consider installing drainage at the rear of the building to divert the water around the perimeter of the building/away from the foundation to prevent possible water penetration into the lower levels of the building.

Direct water away from the foundation
